ENVIRONMENTAL IMPACT STATEMENT

for proposed
Railway Ballast Quarry
at Martins Creek
in the Shire of Dungog

prepared for
State Rail Authority of N.S.W.

by
D.P.JAMES
July 1990

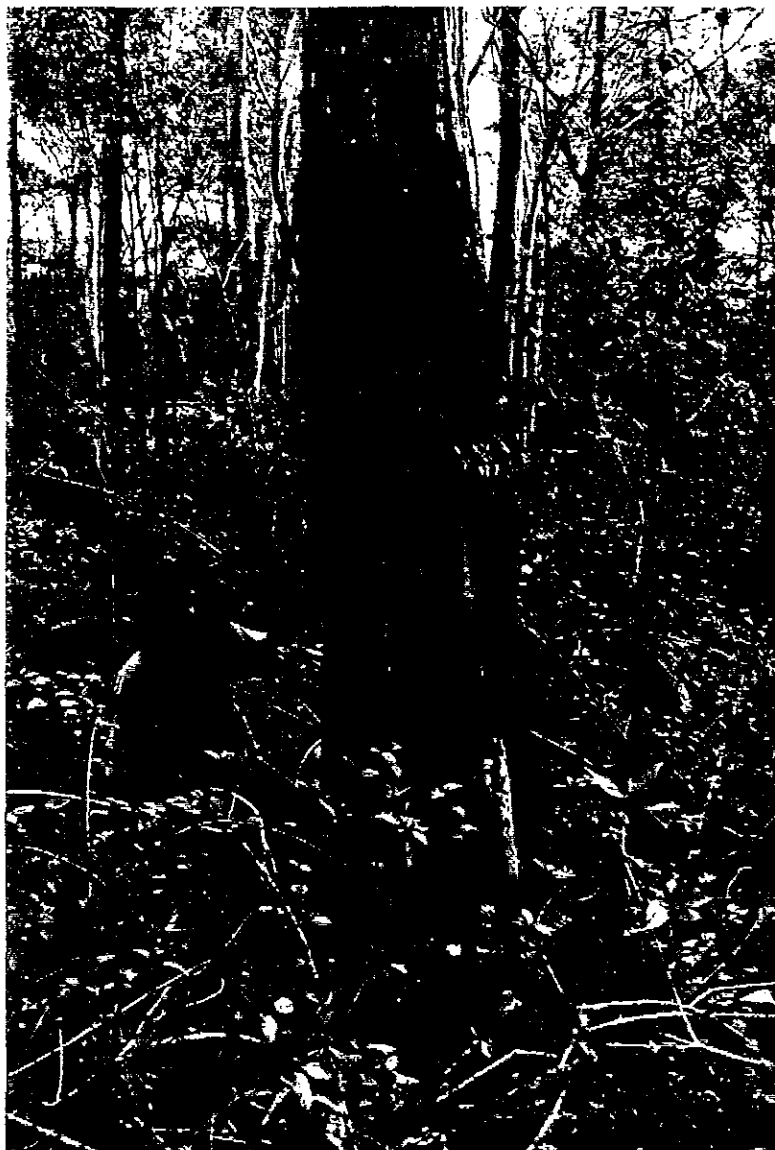
Plate Number 2

Possible Scarred Tree - Find No. 3
Shows western slope vegetation
